2) Barrier – Naturaservis s.r.o., Zamenis, o.s.

3) Biotope Care, Ing. Haleš, Czech Union of Nature Conservationists

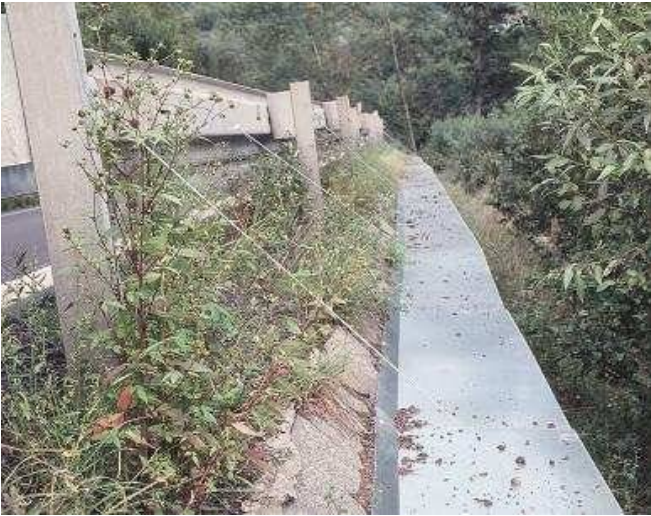
Fig. 8: Barrier preventing snakes from entering the road, it is slightly inclined so that young snakes could not climb from the river to the road but so that it could be an obstacle in the opposite direction

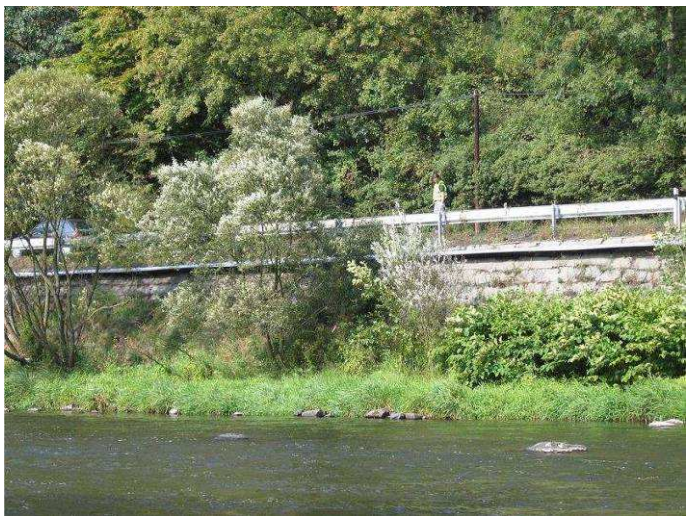
Fig. 9: View of the barrier from the opposite bank of the Ohře river, length more than 200 m

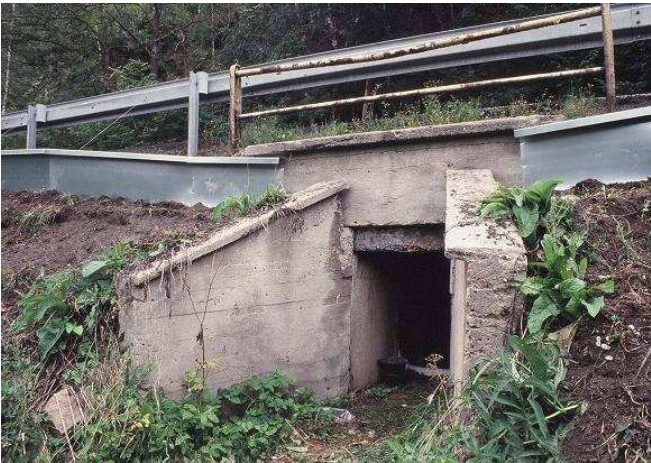
Fig. 10: Culvert to which snakes are guided

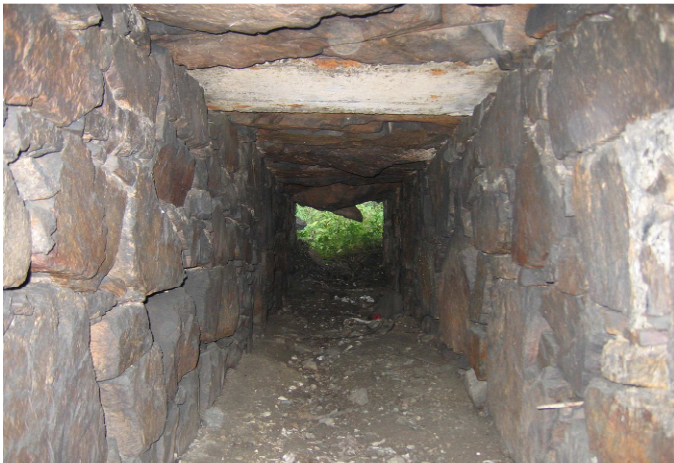
Fig. 11: Inner walls of the culvert composed of stones are optimal for snakes (it may be used in the same way as dry stonewalls)

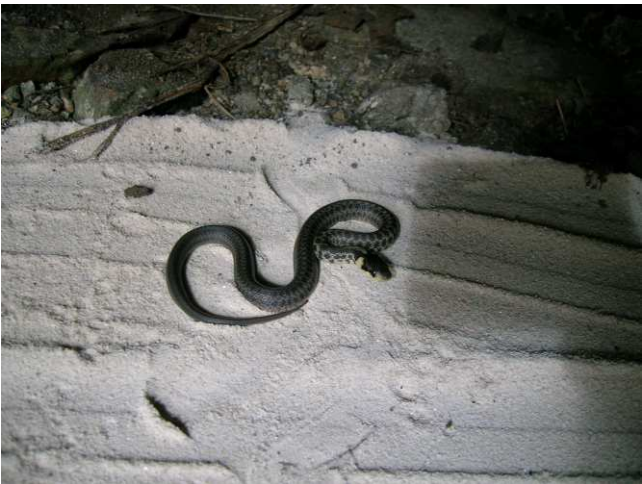
Fig. 12: Young snake safely guided to the culvert below the road
